RECONDITIONING OF HISTORIC VEHICLES

ABSTRACT: The restoration of classical cars consists of bringing the car to its original technical and aesthetical state, as it was designed by the manufacturer.

The first part of the paper presents a particular case, the Trabant 6001 car, which was entirely restored by me as part of an ongoing project, and a Dacia 1300 which is scheduled to be reconditioned.

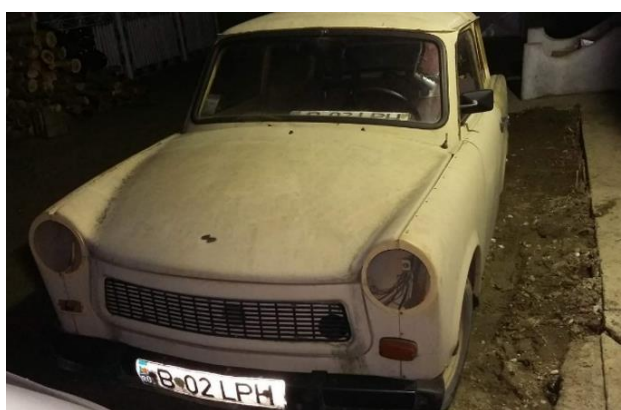
Fig. 1. Trabant 601

The entire reconditioning process began in 2019 and it started with a video clip I saw on youtube. I liked the car so I started searching for one that I could restore. Once I purchased the car (figure 1), I began working on it, putting in a lot of passion.

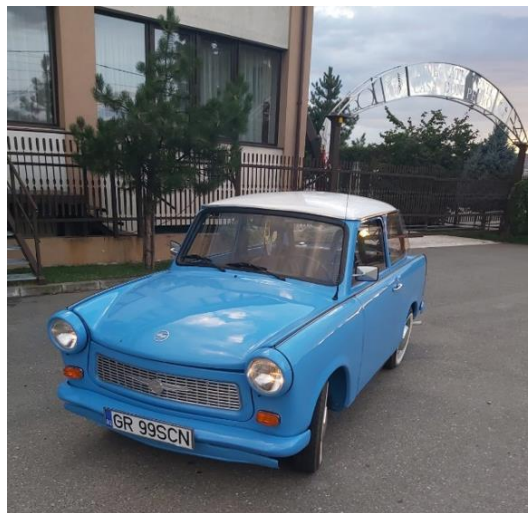
Fig. 4. Trabant 601 after reconditioning

After approximately one year and a half of working on it, the car came to look exactly as I wanted (fig. 4).

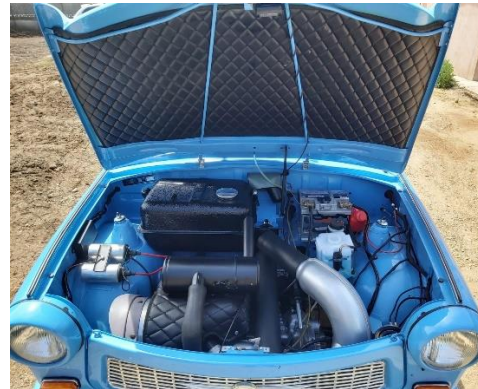
Fig. 6. The engine

The Trabant 601 has an Otto engine operating as a two-stroke cycle, which means that the whole sequence of events, intake, compression, power and exhaust are completed in two strokes of the piston. The engine has two cylinders, the cylinder bore is 72 mm, the piston path is 73 mm, the stroke capacity of 594,5 cm^3 , compression of 7,6 and the maximum engine output of 19,1 KW (26HP) at 4200 rot/min [2].

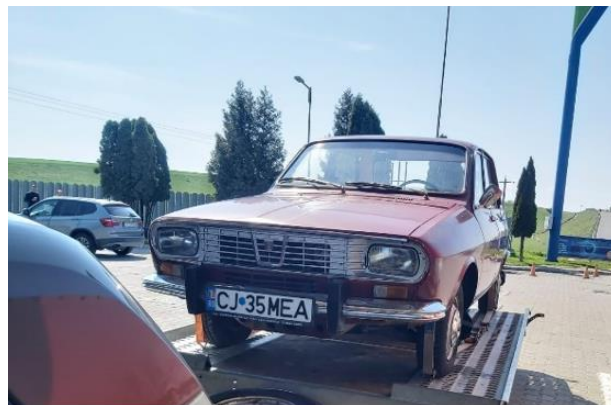
Fig. 7. Dacia 1300

Born and raised with a Dacia on my threshold, like any Romanian, I chose to restore a Dacia 1300 manufactured in 1974. I began the restoration process on April 25th, 2023 and hope to finish it this summer.
