IMPROVING THE HOUSING STRUCTURE

SUMMARY: The need for consolidation works of the existing constructions takes a very large scale with the passage of the years, mobilizing human and material resources comparable to those used for new investments. The consolidation of the structures must be carried out on the basis of clearly and coherently expressed principles, leading to the achievement of safe constructions with a predictable seismic vulnerability to the incidence of an earthquake of maximum probable intensity. The objective of the work is to establish the causes that lead to the degradation of the constructions, the elimination of these causes and the proposal of consolidation measures, of the degraded structural elements, following the qualitative evaluation as well as after the verification of their bearing capacity in accordance with the standards and norms in force. The present study aims to analyze the behavior of some constructions subject to seismic action.

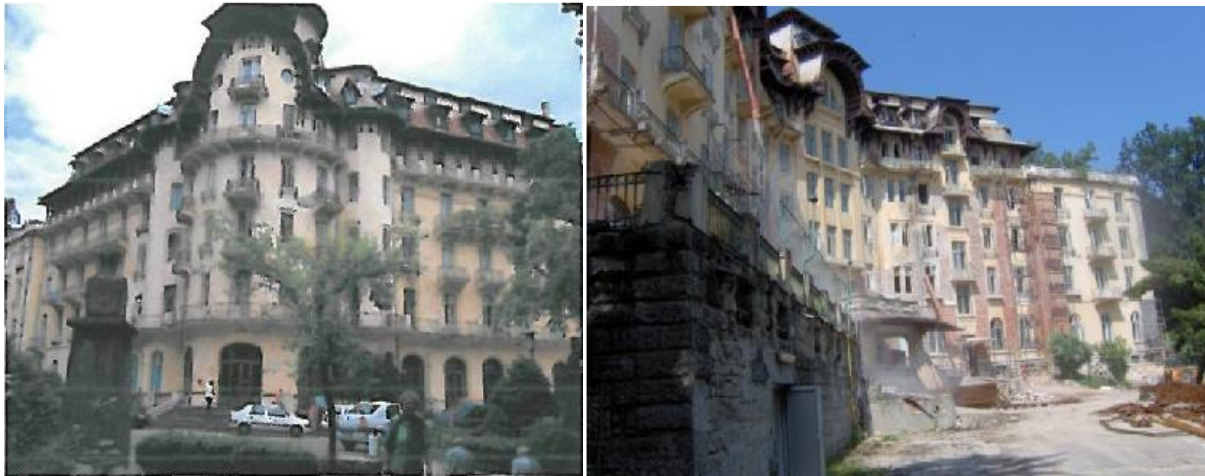
Fig. 2 Hotel "Palace" (main façade and secondary façade)

Historical monument, emblem of the resort, built between 1911–1914, HOTEL "PALACE" (Fig. 2) was the first hotel with a treatment base in Romania, built after the plans of the French architect Eduard Doneaud, the works being coordinated by the Romanian engineer Bratescu and the Italian engineer Pukliky. The architecture of the building is eclectic with art influences nouveau and elements of neo-Romanian architecture. For the weight of the construction to be cat smaller, the dividing walls were made of cork. The building has 365 voids (doors, windows, etc.), the figure symbolizing the number of days in a year. Luxury hotel at that time, the Palace was built in the middle of the resort park arranged by the French landscape architect E.Pinard. The furniture of the Palace Hotel was made of linden wood, bronze chandeliers and crystal mirrors. Medical equipment was brought to the treatment base from Germany, part of which is still preserved today. Initially, the hotel had no heating system, the activity being seasonal from May 15 to September 15.

Visual inspection of the construction is an important activity that helps us to observe the possible irregularities in both the structural and non-structural elements. In following the visual inspection, the building shows a degree of wear due to age and lack of major and uniform interventions to maintain the building. In many areas (especially bathrooms) concrete from floors and beams shows segregations and lack of covering concrete, with reinforcement appearances, corroded, exterior and interior finishes are partially degraded, floors and the carpentry is partially degraded.

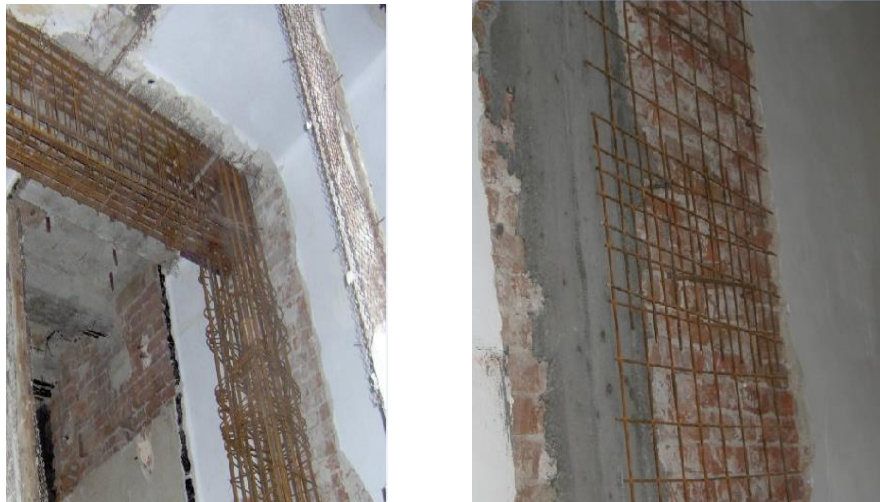
Fig. 4. Reinforcement of the consolidation framework

- strengthening of brick screeds with carbon fiber;
- arrangement of closed reinforced concrete frames throughout the height of the building;
- consolidation of the floors in the basement, by cleaning with the sandblasting method or with jet of air, replacement of corroded or broken reinforcement by welding, restoration of the concrete layer by plastering and restoration of plasters;

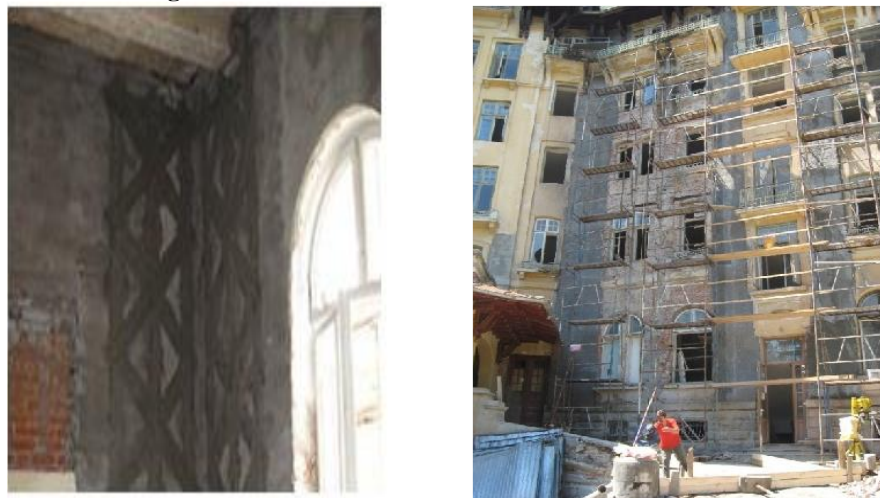
Fig. 5. Strengthening masonry screeds with carbon fibers

1. Preparation of the support by mechanical means and removal of dust. It is recommended that all living edges beveled and rounded.
2. A layer of epoxy adhesive is applied to the area of consolidation.
3. Apply the carbon strip, pressing it on the adhesive using a plastic roller, so that the adhesive passes through the carbon fibers and the fabric is embedded in the adhesive.
4. The adhesive layer is finished with the gleter or trowel.

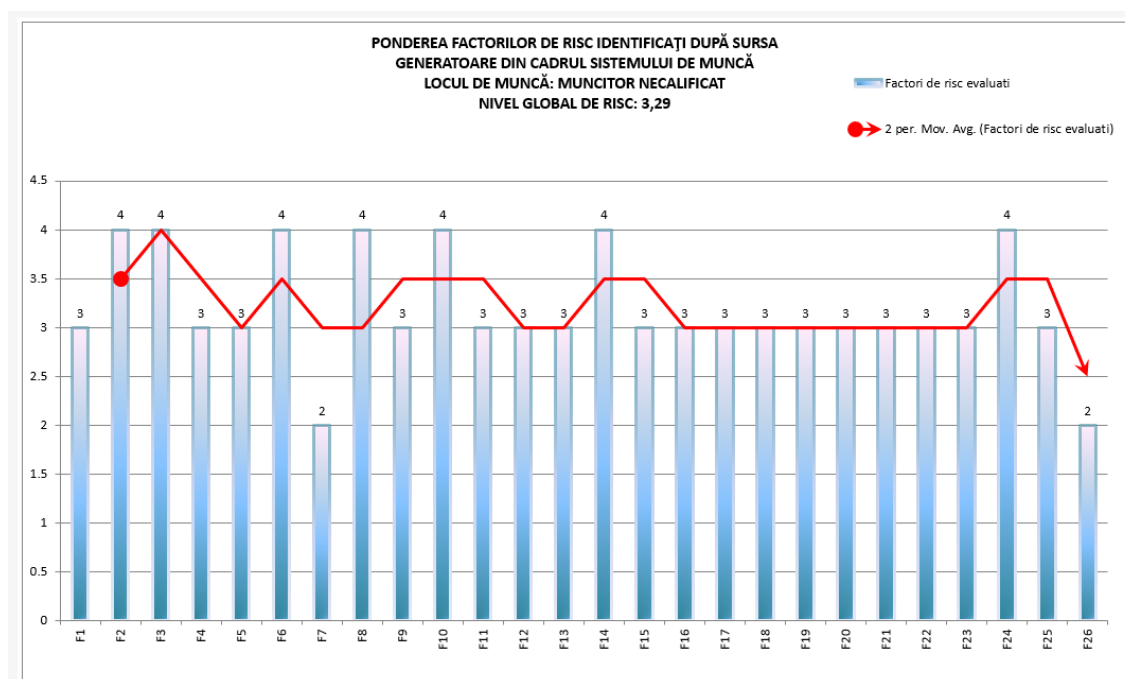
Fig. 6. Share of identified risk factors

RISK FACTORS SPECIFIC TO THE CONTRACTOR
Improper assembly of fasteners for handling and transporting masses;
Fall from a height by stepping into the void, sliding, unbalanced;
Work in electrical installations without qualification and authorization;
Travel, parking in dangerous areas – under the load of lifting means, on the roads
Non-use of the personal protective equipment, non-verification of its integrity, degree of wear, non-replacement of it;
Non-verification of the technical condition of hand tools;
Non-synchronization of teamwork, when transporting or handling heavy materials;
Inappropriate primary relationships (unprincipled relationships between colleagues, tense states, verbal or physical aggressions, deficiencies in the communication system);
Failure to observe discipline at work by presenting to work tired or intoxicated, drinking alcohol during the program.
RISK FACTORS SPECIFIC TO THE TASK

Non-marking or non-marking of dangerous workplaces;
Dynamic handling effort, transport, bulky load storage.;
Forced or vicious working positions producing disorders of the osteo-musculoskeletal system;
Manual handling of masses weighing more than 25 kg, without help
RISK FACTORS SPECIFIC TO THE MEANS OF PRODUCTION
Hitting by means of transport when moving the pedestrian or during the loading/unloading operation;
Use of improper hand tools;
Free fall, overturning, free leakage under the effect of gravity of objects, materials, tools located at a height;
Use of non-standard ladders and/or scaffolding that is not standardised or without bulwarks;
Not enclosing the work platforms and access stairs located at a height;
Dangerous surfaces or contours, pungent, abrasive, sharp (hand tools, etc.);
Electrocution by direct and indirect touch (defective sockets, cables with damaged insulation, uncarried equipment, etc.);

RISK FACTORS SPECIFIC TO THE WORK ENVIRONMENT
Air currents due to outdoor work;
The high air temperature during the hot period and low in the cold season;
Working at a height in adverse weather conditions;
Natural disasters (earthquakes, etc.);
Pneumoconogenic powders (powders, dust, etc.);
